Fiji Watersheds at Risk

Watershed Assessment for Healthy Reefs and Fisheries

Final Report to the United States Department of State OESI Grant #SFJ600 04 GR 004

December 2005

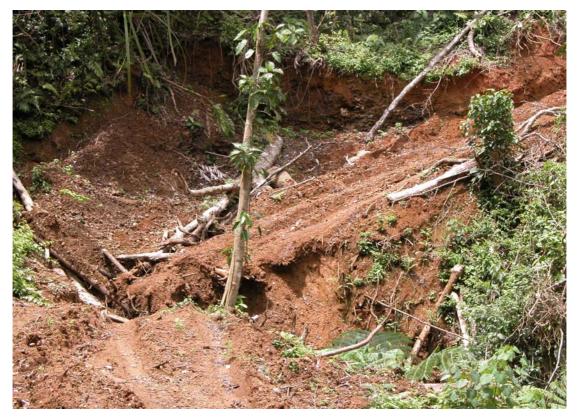
Logging roads cause accelerated soil erosion, especially when designed poorly (WCS).
