Animals Crossing the Northway: Are Existing Culverts Useful?

By SCOTT D. LAPOINT, ROLAND W. KAYS, AND JUSTINA C. RAY

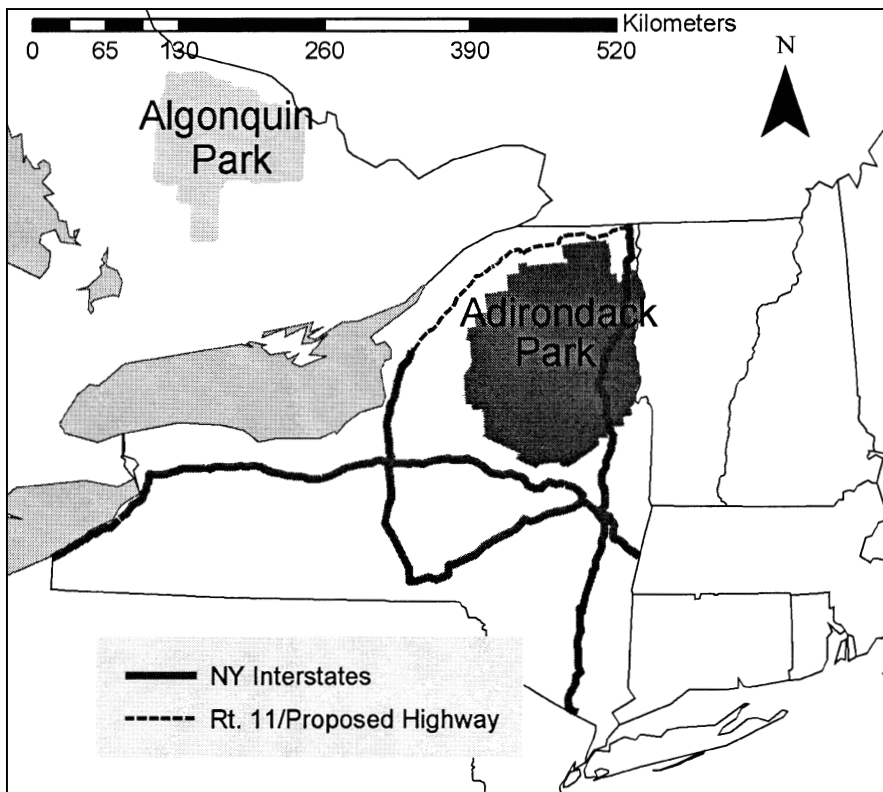
Figure 1.

The Adirondack region of New York is characterized by some of the lowest road densities in the Northeast. It has, however, become virtually isolated from other natural areas in the region by human settlement and agriculture (Figure 1). The area to the north is the least populated region abutting the Park and offers some chance for connectivity to northern wilderness areas in Ontario (Quinby, *et al.*, 1999). Large mammals, such as moose (*Alces alces*), have recently been documented making long-range movements from the Adirondack Park to the Algonquin National Park (Masters, 2001), and conservation planning to enhance potential movement corridors for wolves has been under way for several years (Quinby, *et al.*, 1999).

environment (Figure 1), it is of considerable interest to evaluate the extent to which standard culverts and underpasses constructed under I-87 are actually utilized by wildlife moving east-west.
